**Home Inspection Report for:**

123 Main Street

**123 Main Street**

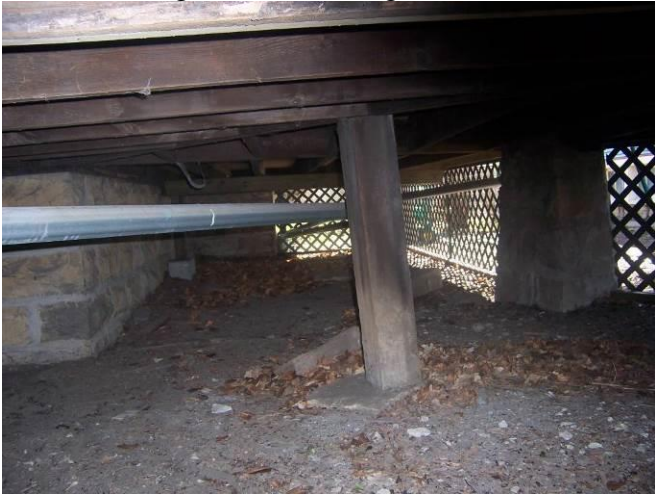
Item	Action	Deficiency
Front porch supports	repair	<p>Several of the support posts at the front porch are not well supported on the ground. Several of the posts appear to be bearing only on a piece of flagstone laid on the ground. All support posts like this should bear on a footing that extends below the frost line. Failure to properly support these posts can lead to settling or frost heaving, or both.</p>

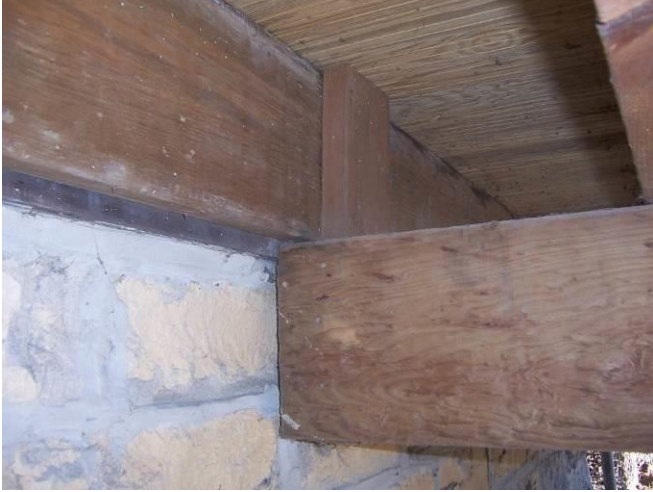
rear deck	repair	<p>The rear deck is poorly supported at the house. The main support beams don't appear to be properly attached to the house structure. This is unsafe. Make repairs as required. It appears that the deck can be left in place and additional support added.</p>

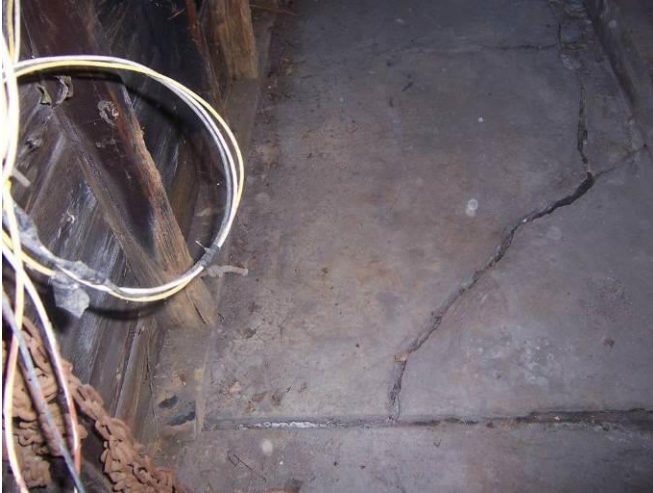
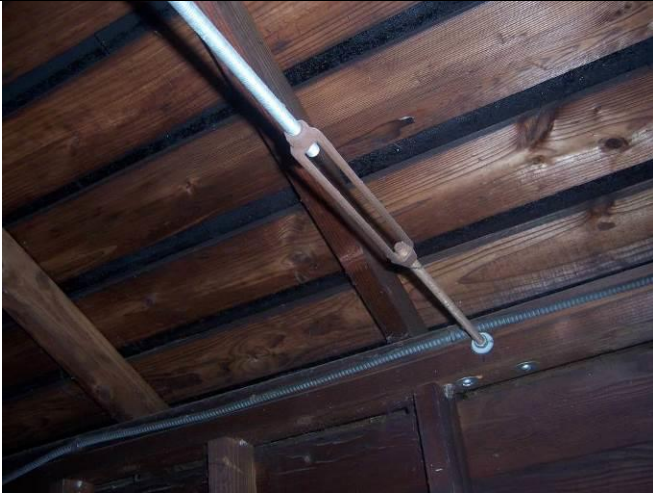
garage	repair/ replace	<p>The garage slab/foundation has settled, especially at the west side. The walls, especially the west wall, are not properly supported and are leaning due to the settling of the slab. Supplemental supports in the form of steel rods have been added to help support the walls. The garage structure is unsafe. Replace the garage.</p>

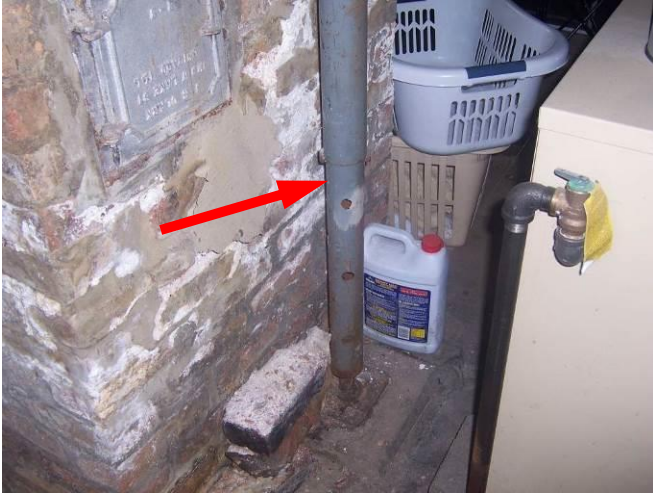
support post	replace	<p>There is a support post in the basement near the chimney that is not designed or intended for permanent installation. Failure of this post would cause severe structural damage. Consult a well-qualified contractor to install a proper, permanent support post.</p>

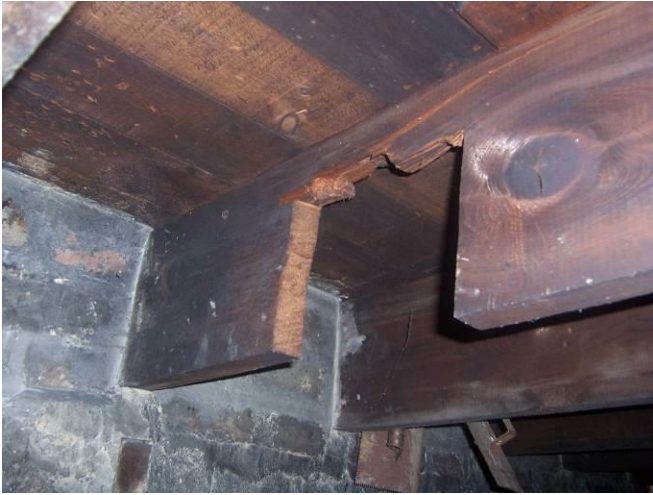
floor joist	repair	<p>There is a floor joist that is notched excessively. This joist is incapable of carrying any significant load.</p>

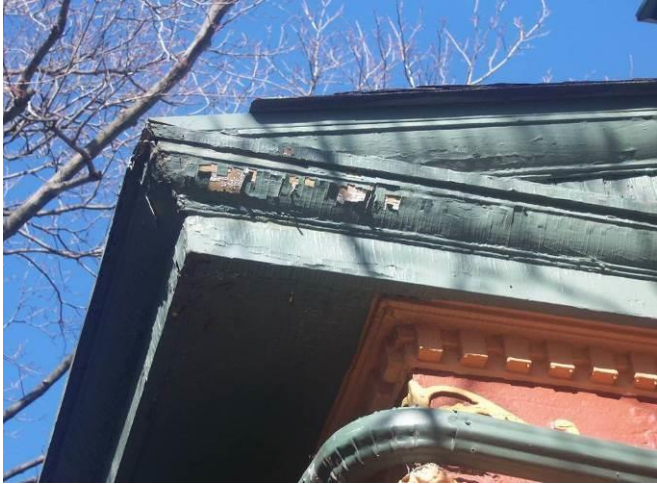
Item	Action	Deficiency
siding and trim	paint	<p>There is peeling paint at several locations at the exterior. Exterior paint generally lasts no more than 5-10 years at best. Paint is not only decorative but also helps to protect the wood it covers from rot and decay.</p>

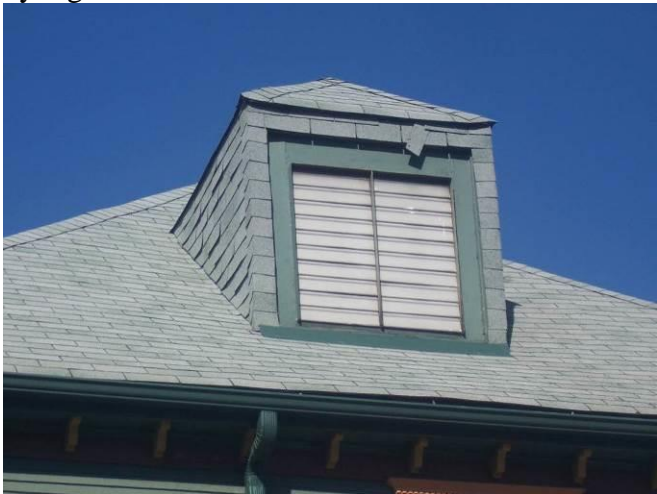
dormer siding	repair/replace	<p>Asphalt shingles are used as siding material at the dormer. When asphalt shingles are installed vertically like this then special rules apply to how they should be installed, and it's pretty clear that these shingles weren't installed correctly. This makes them more susceptible to leakage from wind-driven rain, and to being torn off by high winds.</p>

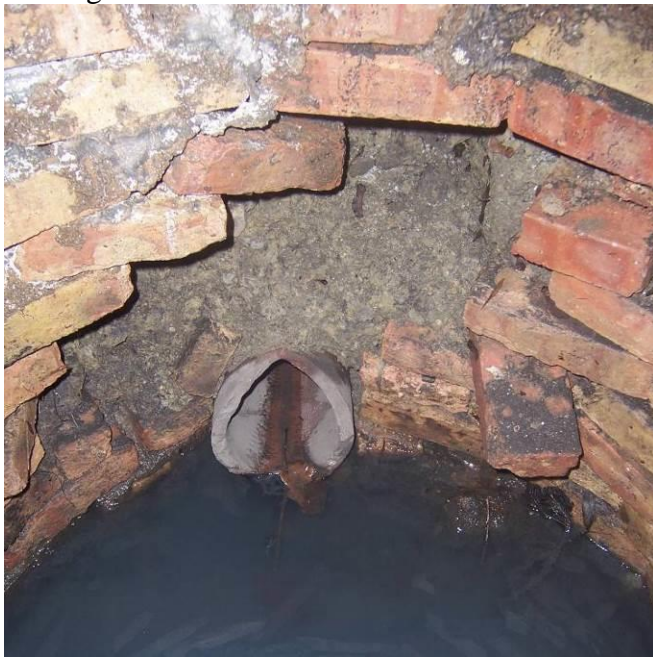
Item	Action	Deficiency
grease trap	repair	<p>The structure of the grease trap is compromised. See picture. There are missing bricks. This can allow earth to collapse into the grease trap, causing clogs to the pipes and a sink hole in the ground above. Also, collapse of bricks into the grease trap may occur, again leading to blockage and further collapse of the ground above.</p>

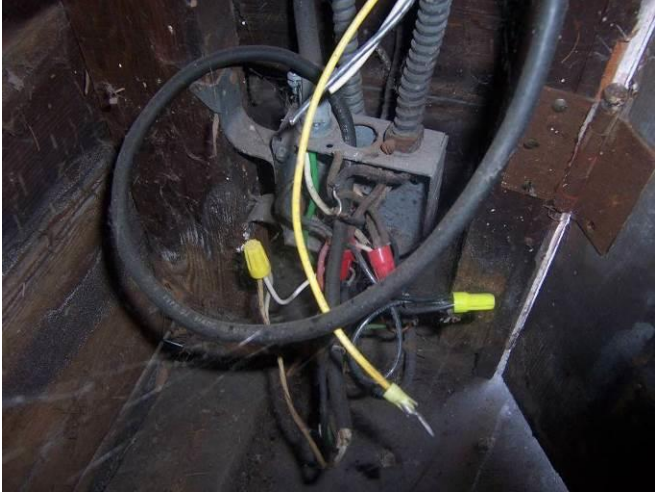
Item	Action	Deficiency
garage wiring	repair/ replace	<p>All of the electrical wiring in the garage is sub-standard and is unsafe. There are exposed wires that aren't protected in any way. There are electrical splices that are hanging out of the electrical box. There is extension cord wiring used to provide power to the exterior light. This is unsafe. Have a licensed electrician make the required repairs.</p>

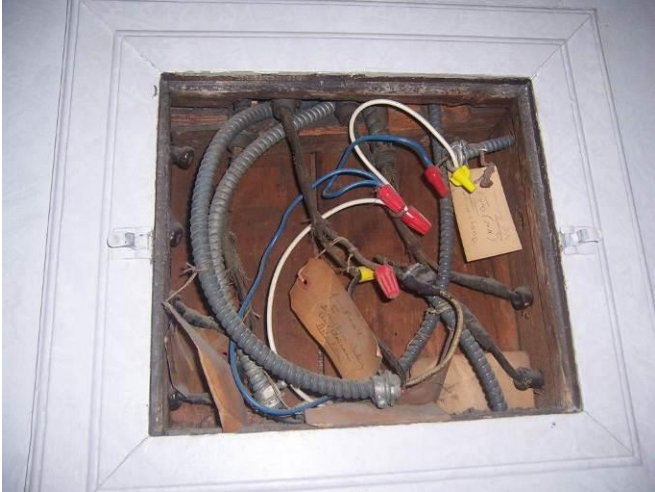
electrical box, 2 <sup>nd</sup> floor	replace	<p>There are electrical splices made inside a wood box at the 2<sup>nd</sup> floor. This older box is not an approved electrical box and it's a fire hazard. Have a well-qualified licensed electrician install a proper listed electrical box.</p>

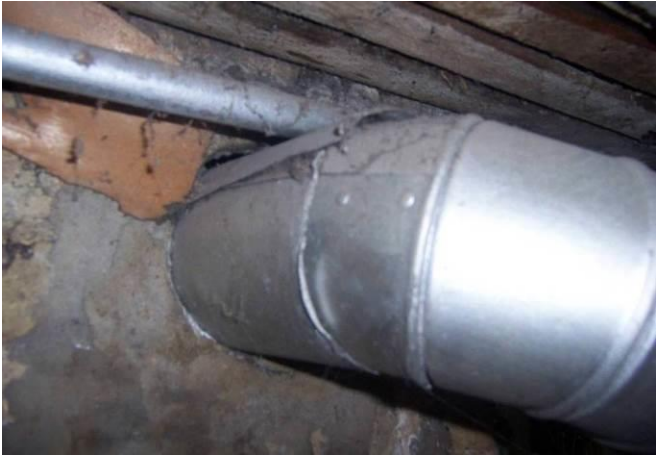
Item	Action	Deficiency
water heater flue	repair	<p>The water heater flue is poorly installed. There are joints in the flue that are not properly connected with screws or other mechanical fasteners. The flue is not well sealed into the chimney. The flue is unsafe.</p>

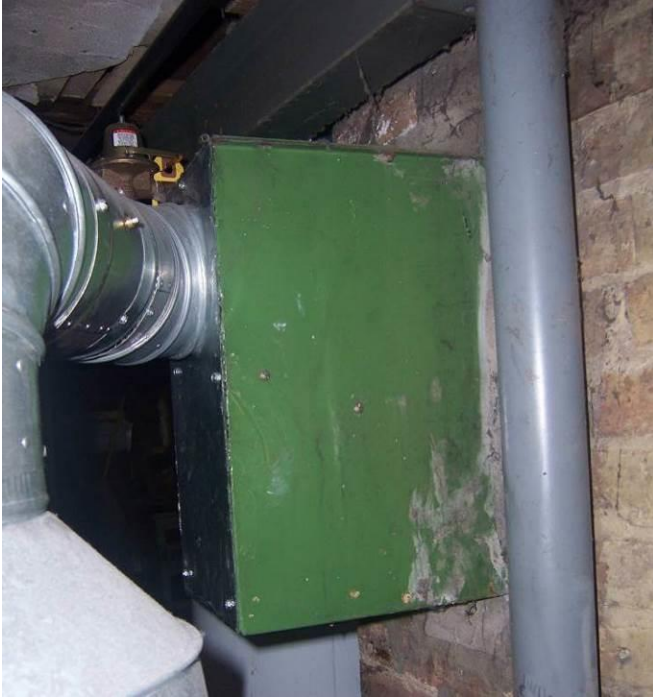
boiler flue	repair	<p>The boiler flue goes through a green box before it enters the chimney. This green box may be a remnant of an old type of draft hood which is antiquated technology and no longer should be used. It cannot be determined during a visual inspection to determine if the newer boiler flue goes directly through this green box and into the chimney. If the flue does not go through the green box, if the box is part of the flue system, then the flue is unsafe. Old, unused components should be removed as they are taken out of service. Have a well-qualified HVAC contractor confirm that the boiler flue is installed properly.</p>
